TRB 2016 Summer Workshop | July 28, 2016

*Optimizing the Nutrient Removal
Performance of Stormwater BMP's
Within the Right-Of-Way*

R-4436EG Stormwater BMP Retrofits

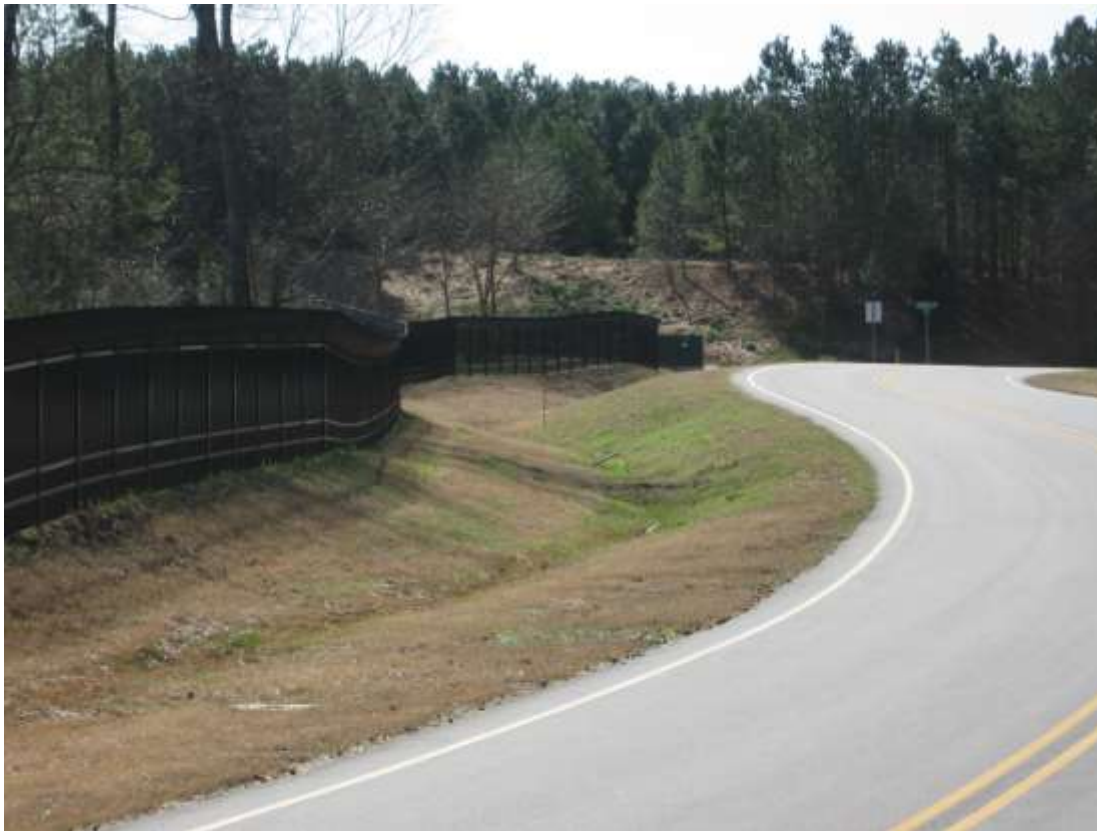
- Typical Swale section
 - Good for treatment
 - Limited greatly by flow characteristics (flow, velocity etc.)
 - Little to no volume reduction

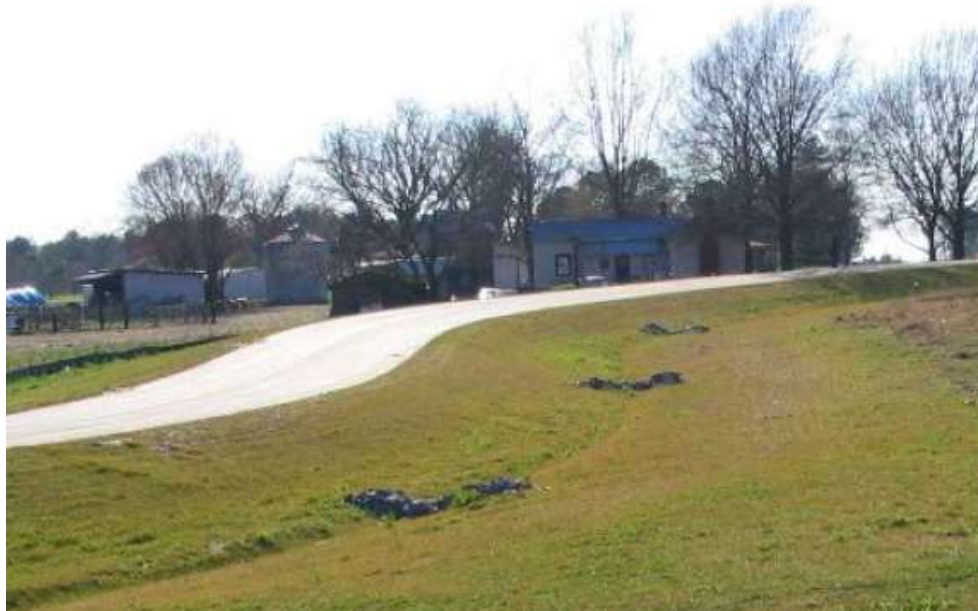
- Research project with **NCSU-BAE**
 - Part of the research included incorporating checkdams

- **Mixed Results**
 - No significant difference in pollutant concentration
 - Didn't measure volume at coastal site
 - Volume important to determine actual Pollutant Load
- **Theory: Should see volume reduction in highly permeable soils.**

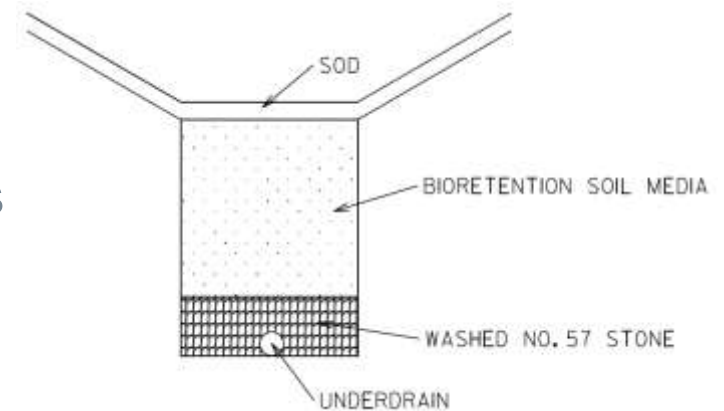
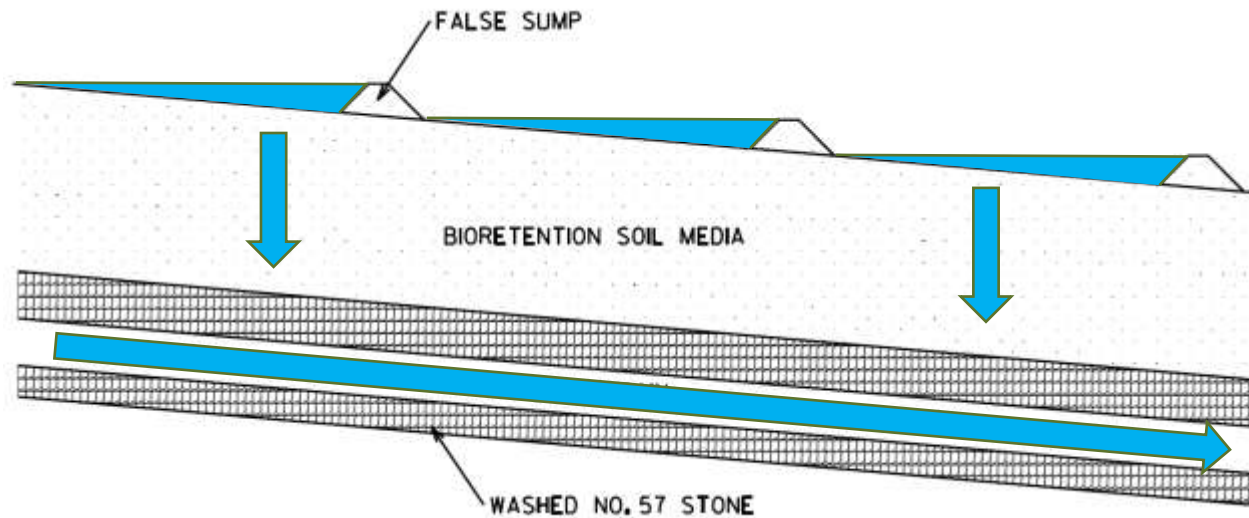
- Bio-swale

- Incorporate highly permeable soils
 - Infiltration capability
 - Filtration
- False Sumps
 - Encourage shallow ponding thus volume capture
 - Benefits over check dams
 - Clear Recovery Zone
 - Mowable

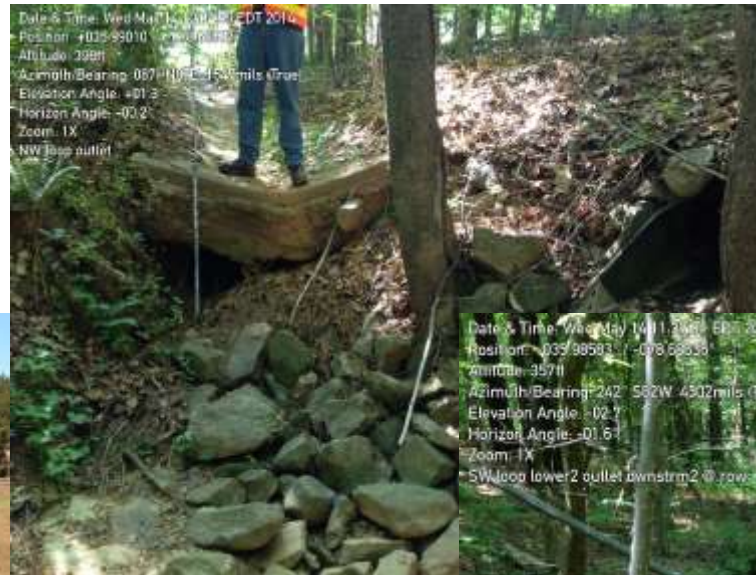
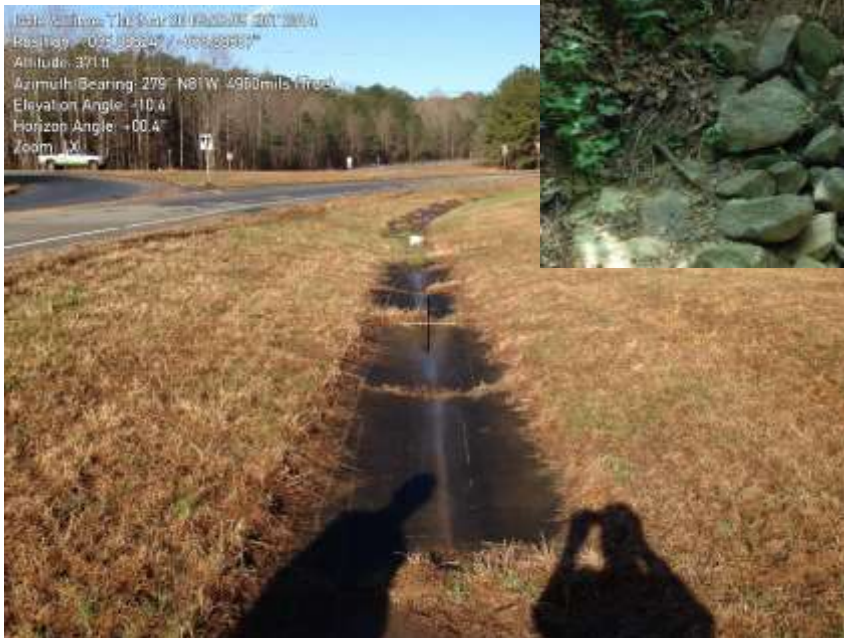
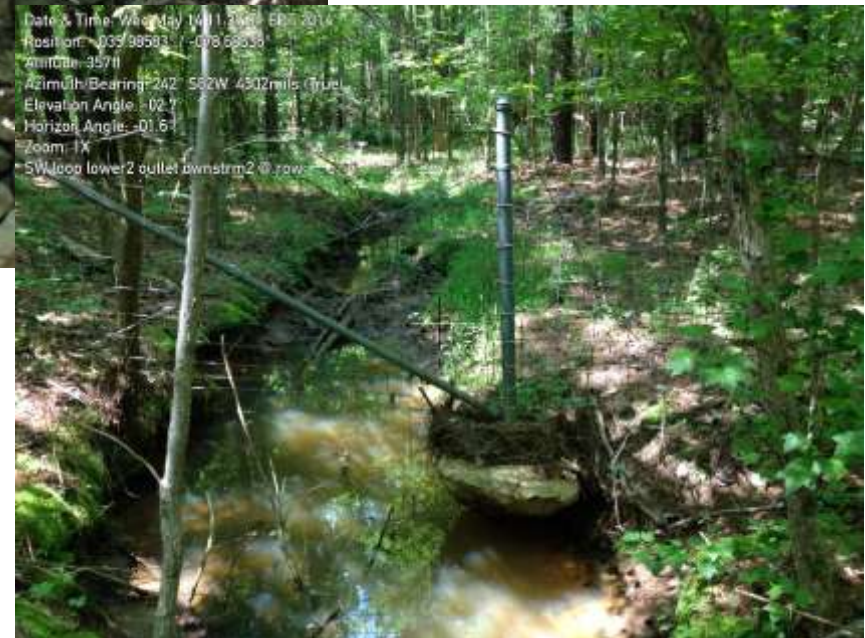
- Existing Conditions
 - Concrete lined ditch conveyance
 - Incised and Eroded Outlets and Downstream Conveyances

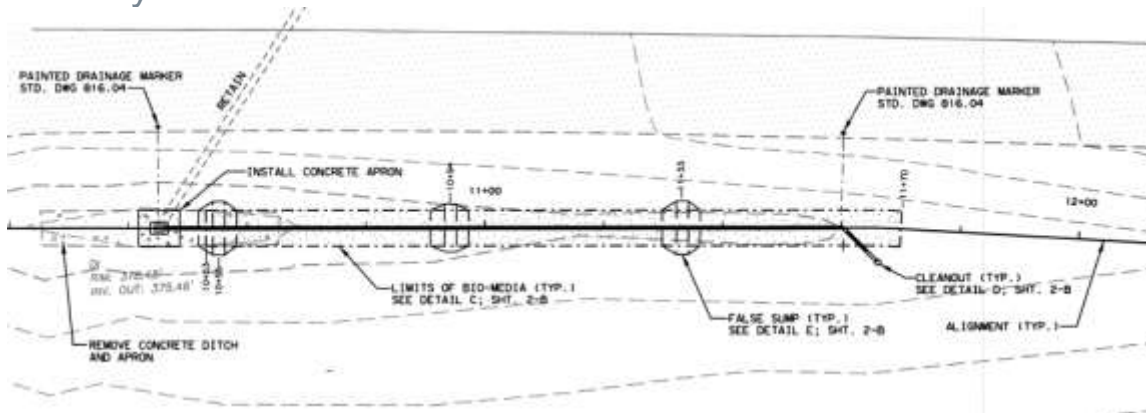
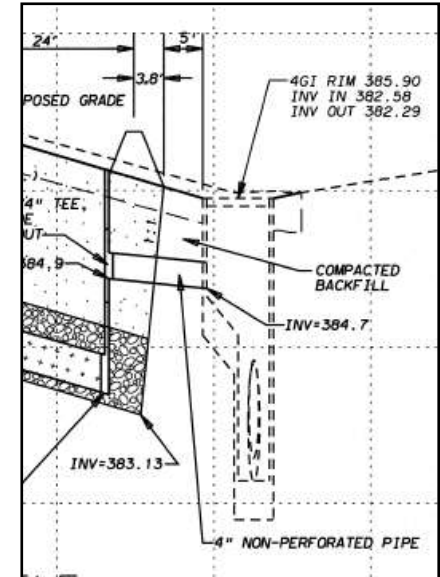
With IWS
(Upturned Underdrain)

- 7 Bio-Swales (2 w/ Internal Water Storage (IWS))
- 2 Swales
- 2 Dry Detention

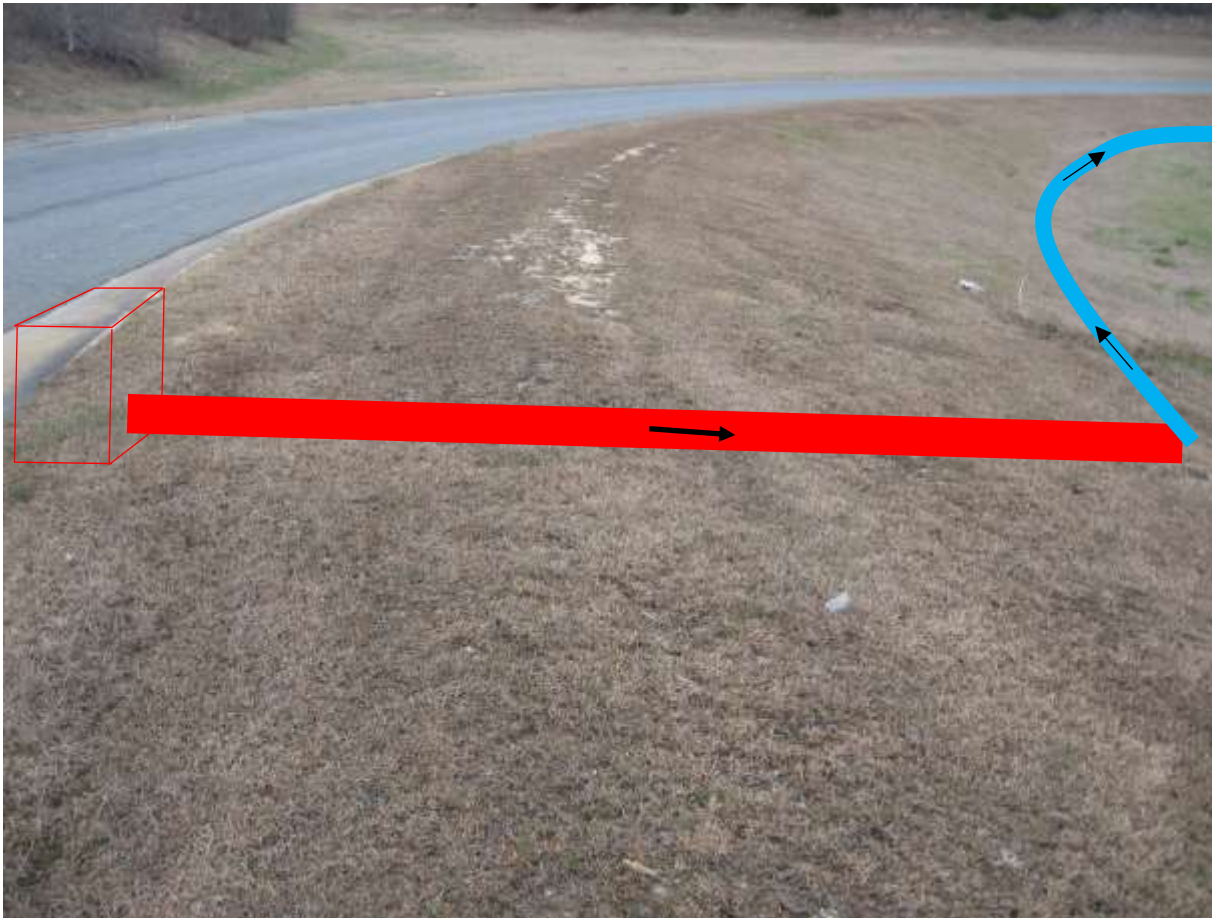
- Existing Loops have Curb & Gutter
 - Runoff doesn't get any treatment
- Proposed new Catch Basins that outlet to new Bio-Swales
 - Treatment through vegetation, sedimentation and filtration

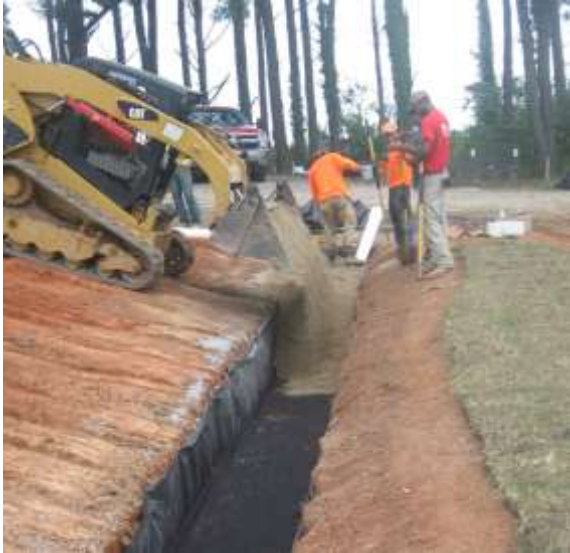
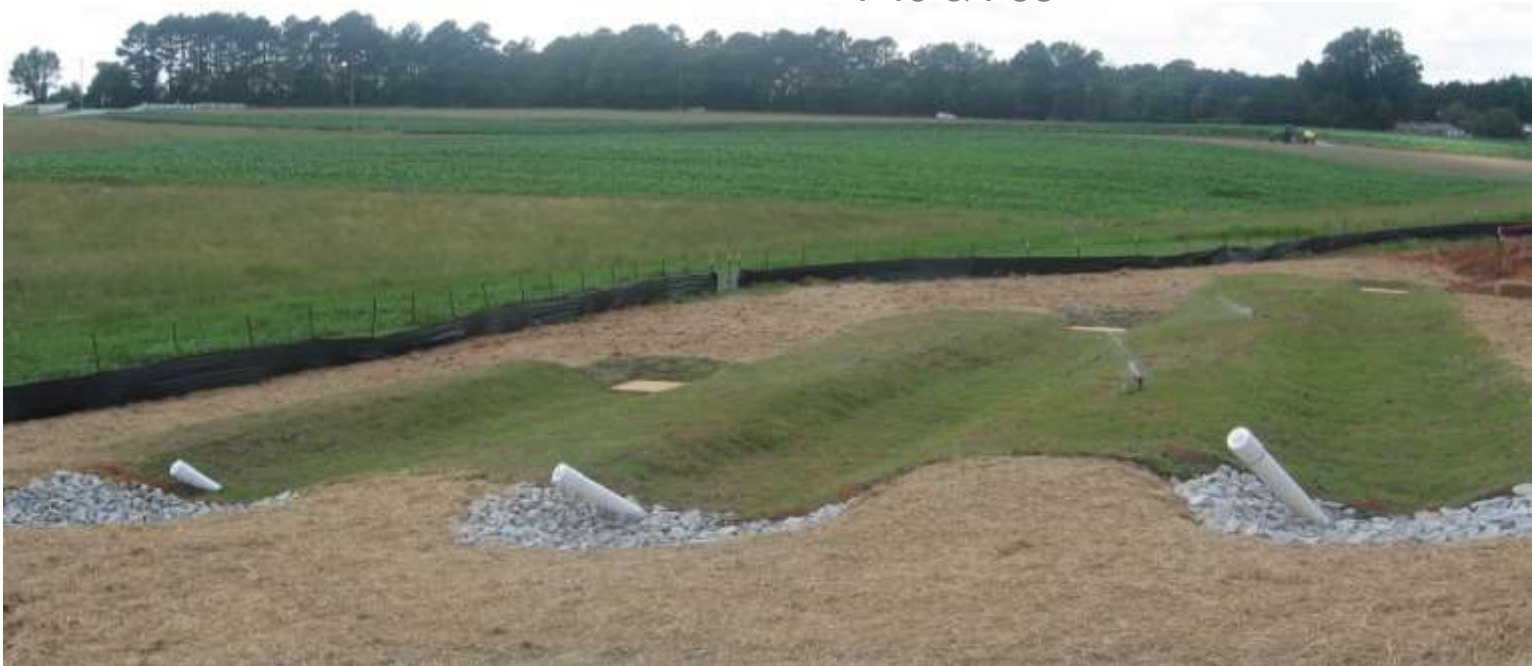
- 'Lab' tests at NCSU – SECREP
 - 6 Bio-Swales constructed
 - 3 lengths
 - 2 slopes
 - With and without check dams/false sumps
 - Controlled Pollutant Concentrations
 - Controlled Flow Rates
- Field Tests & Verification
 - NC 50 & NC 98
 - I-40 & I-95
