PRIORITIZATION OF GROWING BMP MAINTENANCE RESPONSIBILITIES WITH SHRINKING BUDGETS

PRESENTED BY: KAY CABE, PE

*TRB 2016 Summer Workshop Program
Asheville, North Carolina*

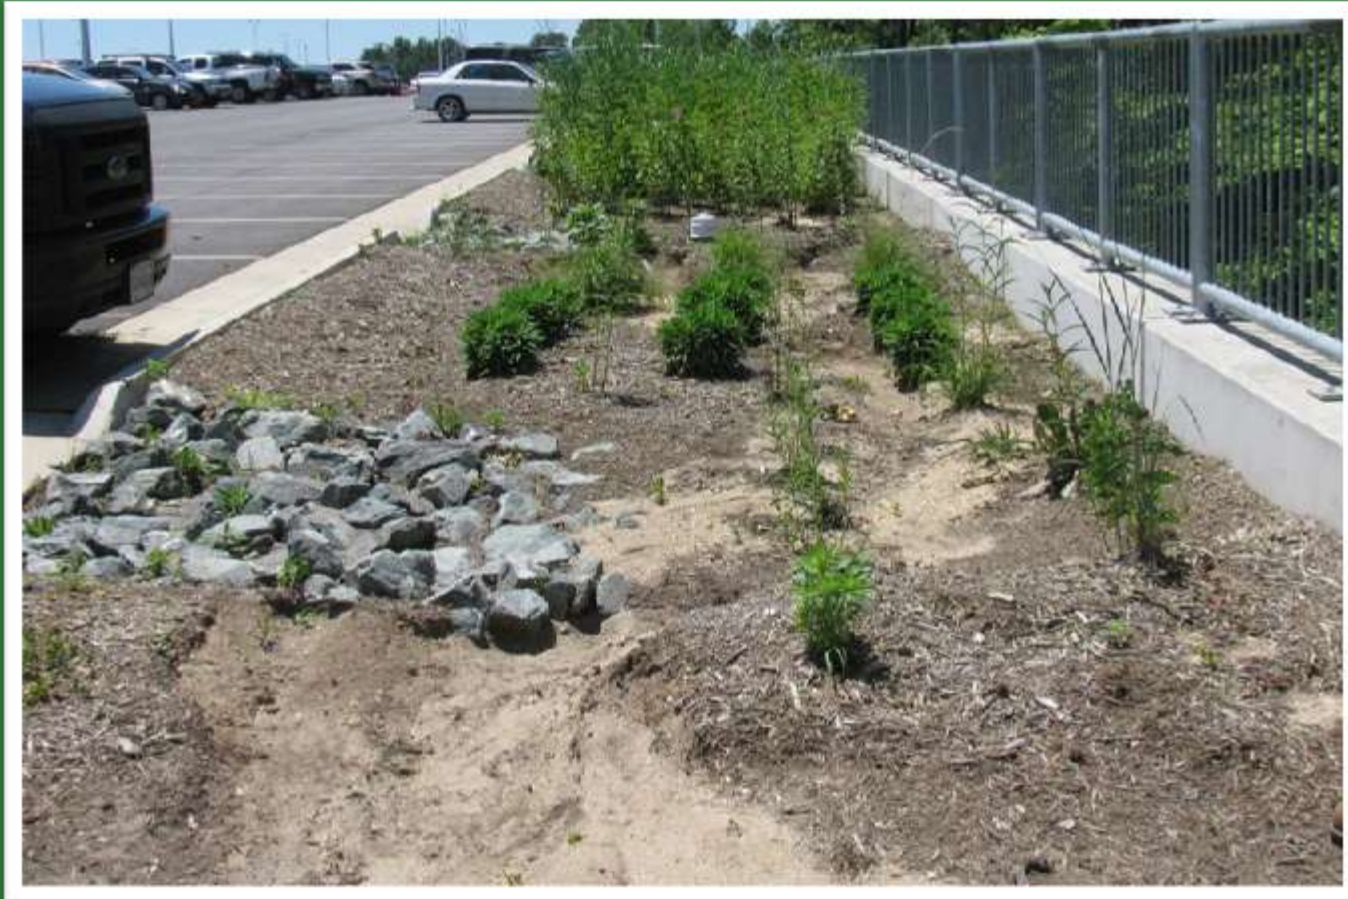
How would you rate this?

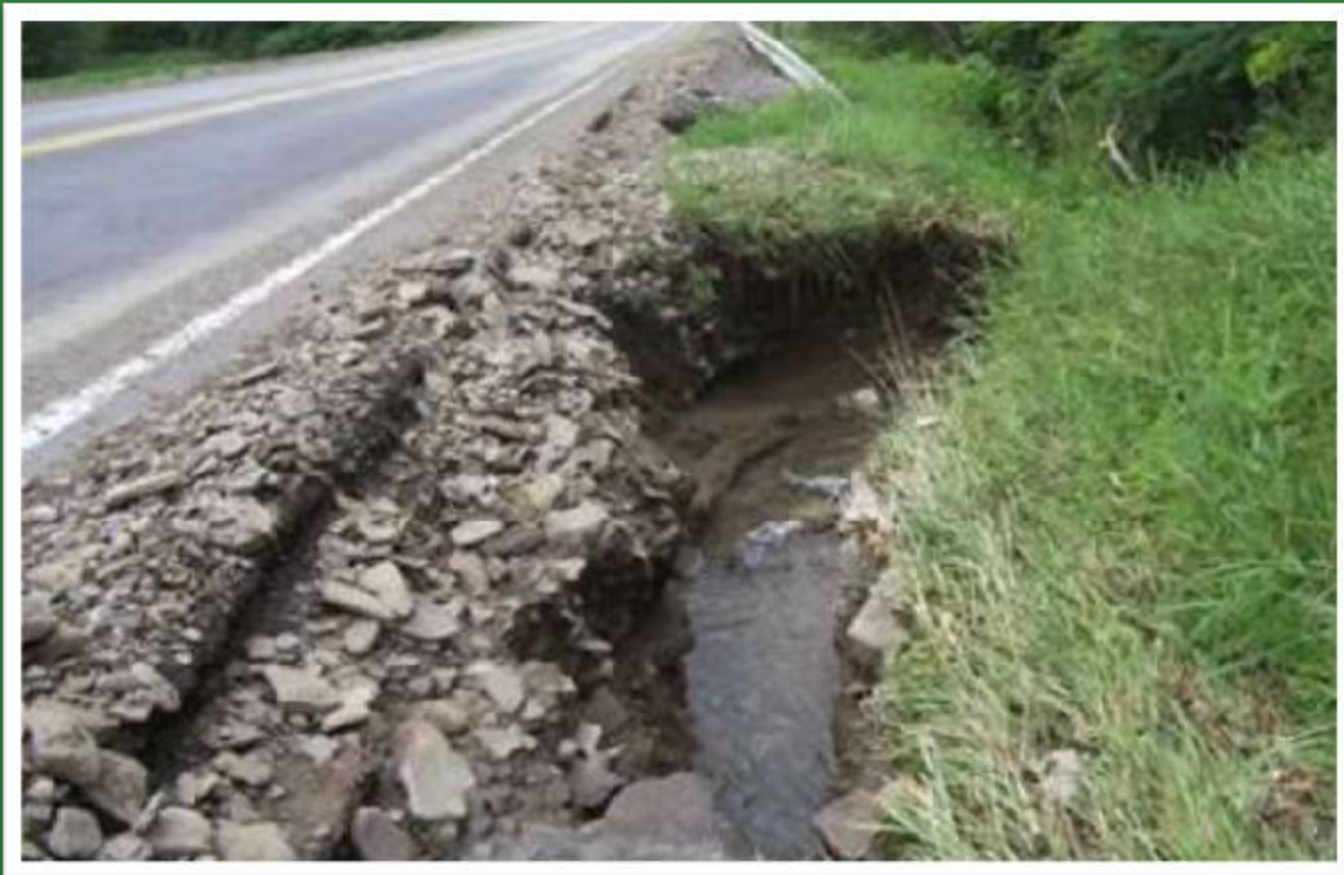
- Major problems and moderate changes in
- Functionality.
- Water Level is raised and structural integrity compromised with signs of impending deterioration. Deficiencies require repair and restoration.
- Maintenance Work Plan: **2-6 weeks.**
Immediate mitigation measures to prevent further deterioration may be required.

How would you rate this?

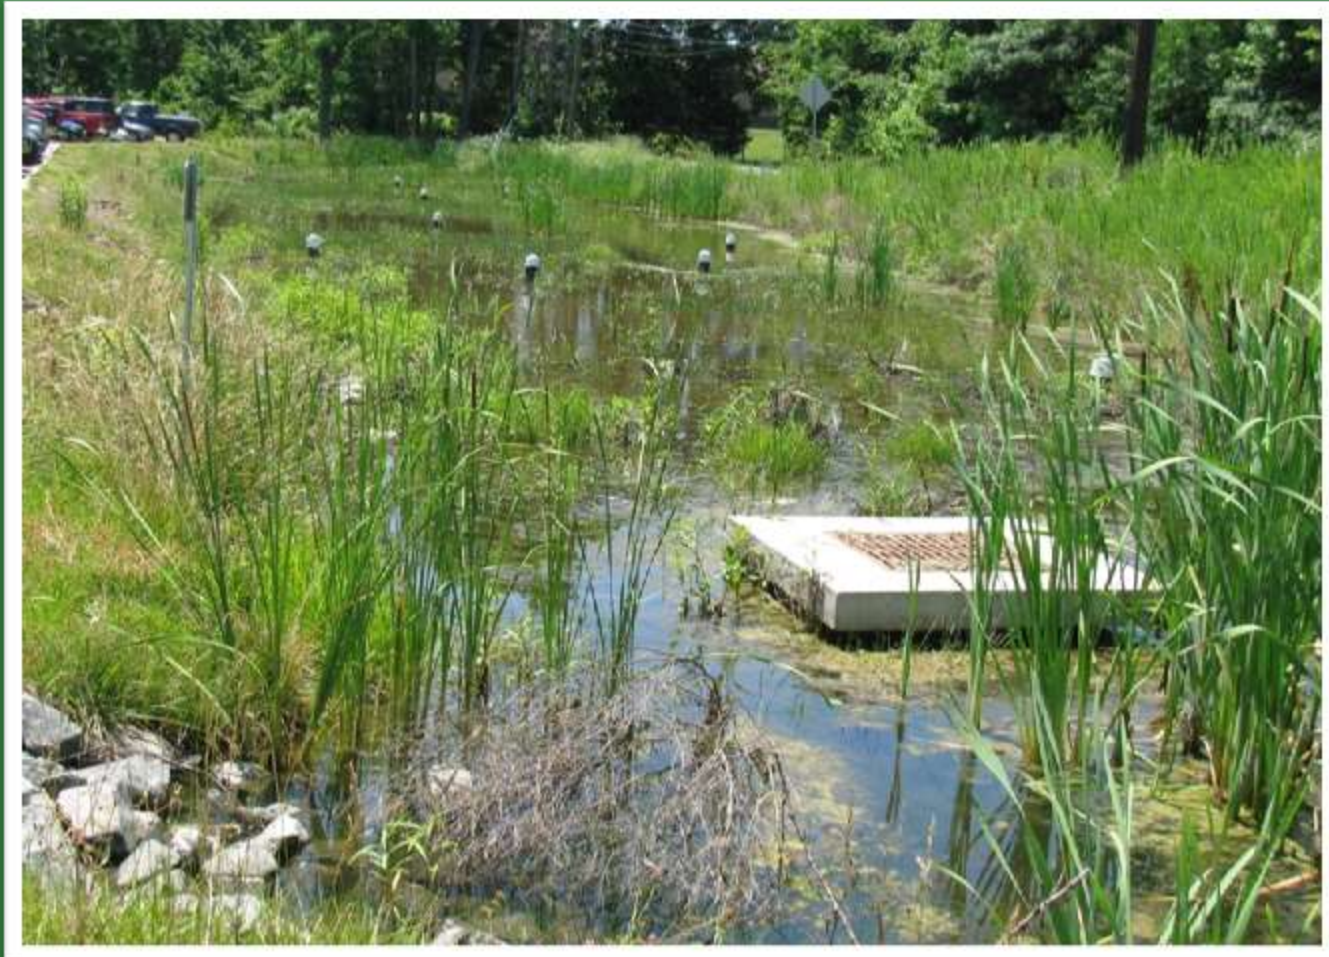
- Severe problems and not properly functioning, further deterioration and/or failure is imminent.
- Repairs and Restoration needed.
- Supervisor inspection required to verify work requirements and determine appropriate
- Maintenance work plan: **within 2 weeks.**
Immediate mitigation measures to prevent further deterioration may be required.
